# Lake Michigan College 2011 Facility Condition Assessment Project Final Report

October 14, 2011

## Lake Michigan College 2011 Facility Condition Assessment Final Report Outline

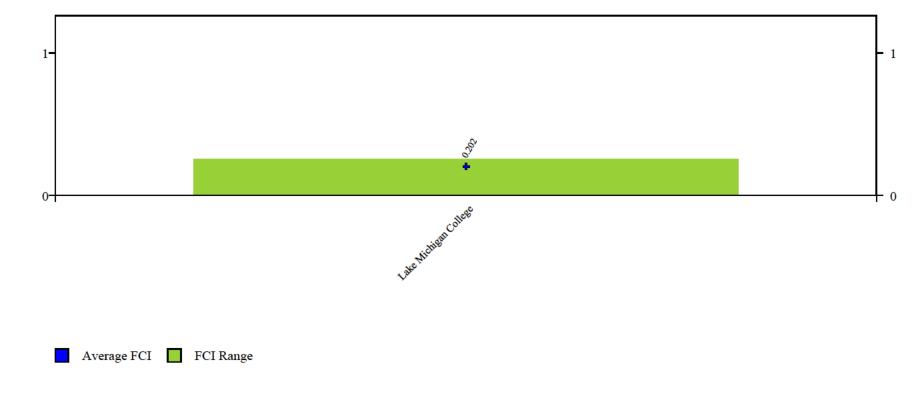
• Portfolio FCI Range: Shows minimum, maximum and group-average facility conditions based on the FCI. The facilities' average age and the backlog (projected costs associated with the group of facilities over the specified timeframe) are also provided.

LAKE MICHIGAN							Executive	e Portfolio Summary
COLLEGE								By Region
	Region	Minimum FCI	Maximum FCI	FCI Range	Average FCI	Average Age	Backlog	
	Lake Michigan College	0.000	0.265	0.265	0.202	21.6	43,589

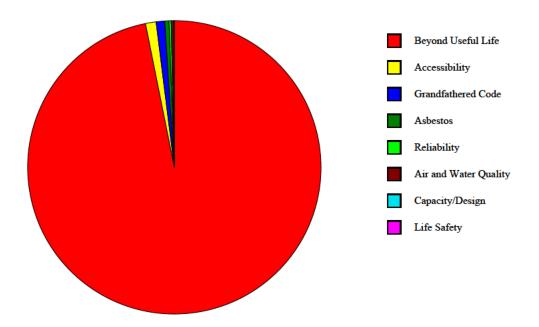
Distribution of Requirement and Renewal Costs

Percentage of
Category	Estimated Cost	Total Cost
Beyond Useful Life	54,936	97%
Accessibility	661	1%
Grandfathered Code	533	1%
Asbestos	264	0%
Reliability	136	0%
Air and Water Quality	132	0%
Capacity/Design	60	0%
Life Safety	3	0%
Total :	56,724

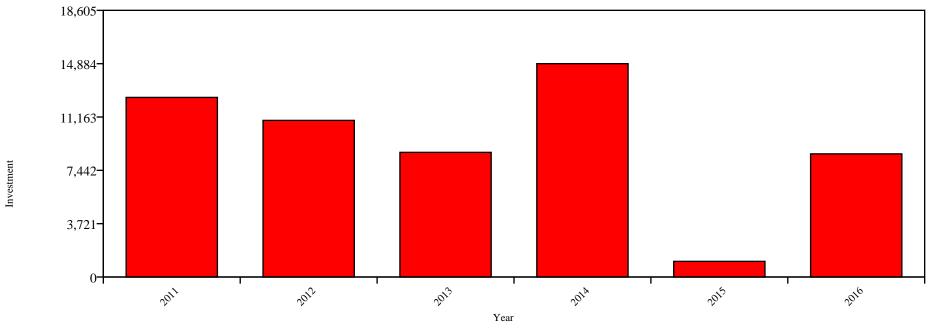
Investment By Region, Per Year

Region	2011	2012	2013	2014	2015	2016	Total
Lake Michigan College	12,531	10,928	8,697	14,886	1,092	8,591	56,724
Total :	12,531	10,928	8,697	14,886	1,092	8,591	56,724

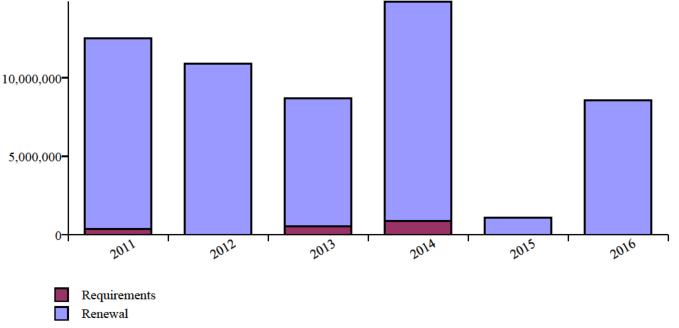
Year	Renewal	Requirements	Total	
2011	12,154,672	376,208	12,530,880	
2012	10,927,606	0	10,927,606	
2013	8,162,051	534,535	8,696,586	
2014	14,009,158	877,074	14,886,232	
2015	1,091,506	0	1,091,506	
2016	8,591,299	0	8,591,299	
Total	54,936,291	1,787,817	56,724,107
